Port Washington-Saukville School District

Athletic & Outdoor Facilities Master Plan Study

Draft: August 2023

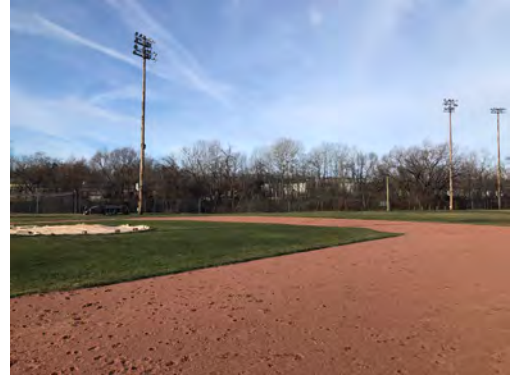
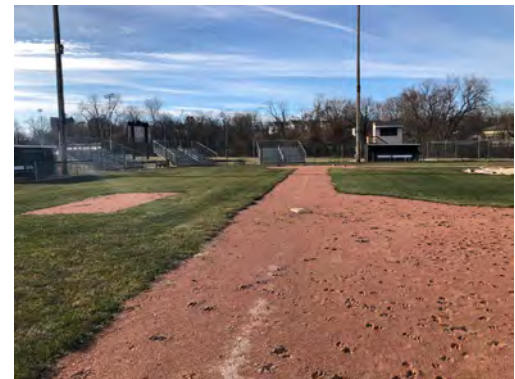
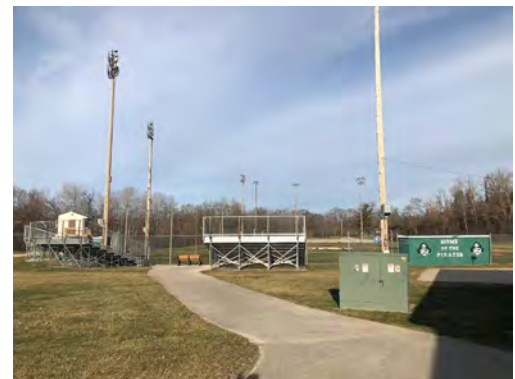
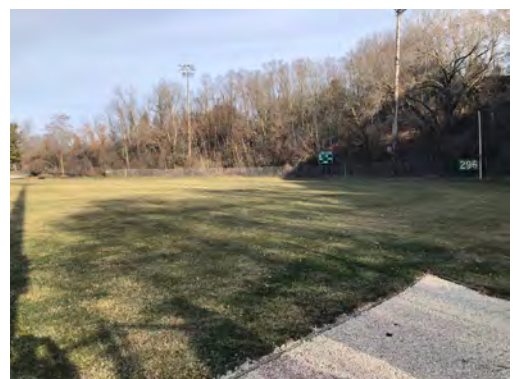
Name:	High School Baseball Field
Field Type:	Baseball
Address:	427 W Jackson Street Port Washington (Port Washington High School Lower Campus)
Amenities	<ul style="list-style-type: none">▪ Bleachers▪ Benches▪ Backstop▪ Concessions▪ Dugouts▪ Restroom▪ Scoreboard▪ Lighting

FIELD NAME: High School Baseball Field		
LOCATION: High School (Lower Campus)		
Specific Area	Rating	Comments
Size (Flexibility)	4	307' / 440' / 296' short in the corners 315' recommended
Drainage	2	
Irrigation	N/A	
Backstop/Dugouts/Bleachers	1.5	
Infield Condition	2	
Outfield Condition	3	
Lighting	2	
Restroom Facilities	3	
Concession	3	
Parking	2	
Fencing	2

Backstop and dugout upgrades recommended. Add irrigation. Line and outfeild fence top should be added if exising fence is to remain.

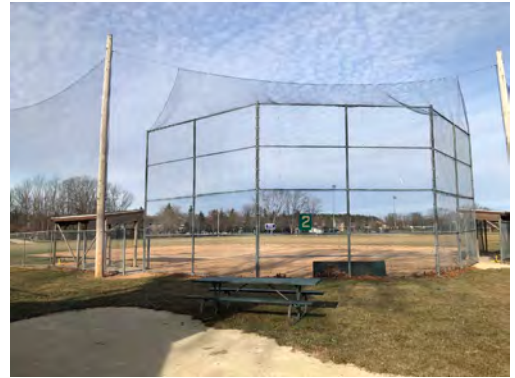
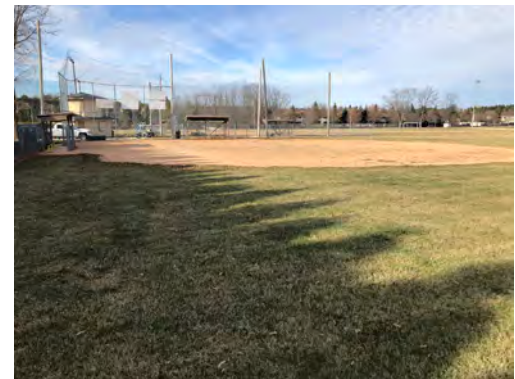
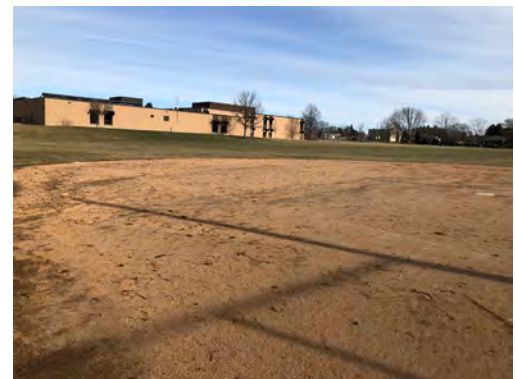
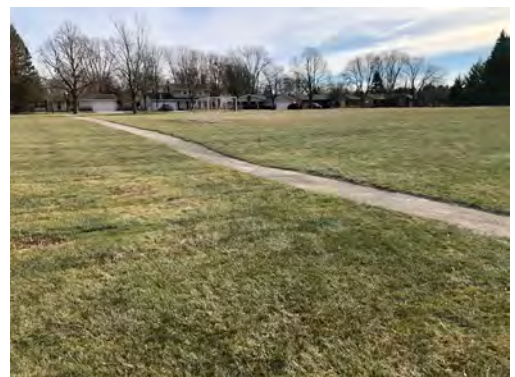
Name:	Thomas Jefferson Middle School
Field Type:	Softball 1 & 2, Practice Soccer
Address:	1403 N Holden Street Port Washington
Amenities	<ul style="list-style-type: none">▪ Bleachers (for Soccer)▪ Benches▪ Backstop▪ Concessions▪ Drinking Fountain▪ Picnic Tables▪ Restroom (Portables)

FIELD NAME: Softball Fields 1&2, Practice Soccer		
LOCATION: Thomas Jefferson Middle School		
Specific Area	Rating	Comments
Size (Flexibility)	4	
Drainage	1	
Irrigation	N/A	
Backstop/Dugouts/Bleachers	1	
Infield Condition	2	
Outfield Condition	2	Combined with practice soccer fields
Lighting	N/A	
Restroom Facilities	1	Portables on site
Concession	2	
Parking	2	Street, or long walking distance parking only.
Fencing	2

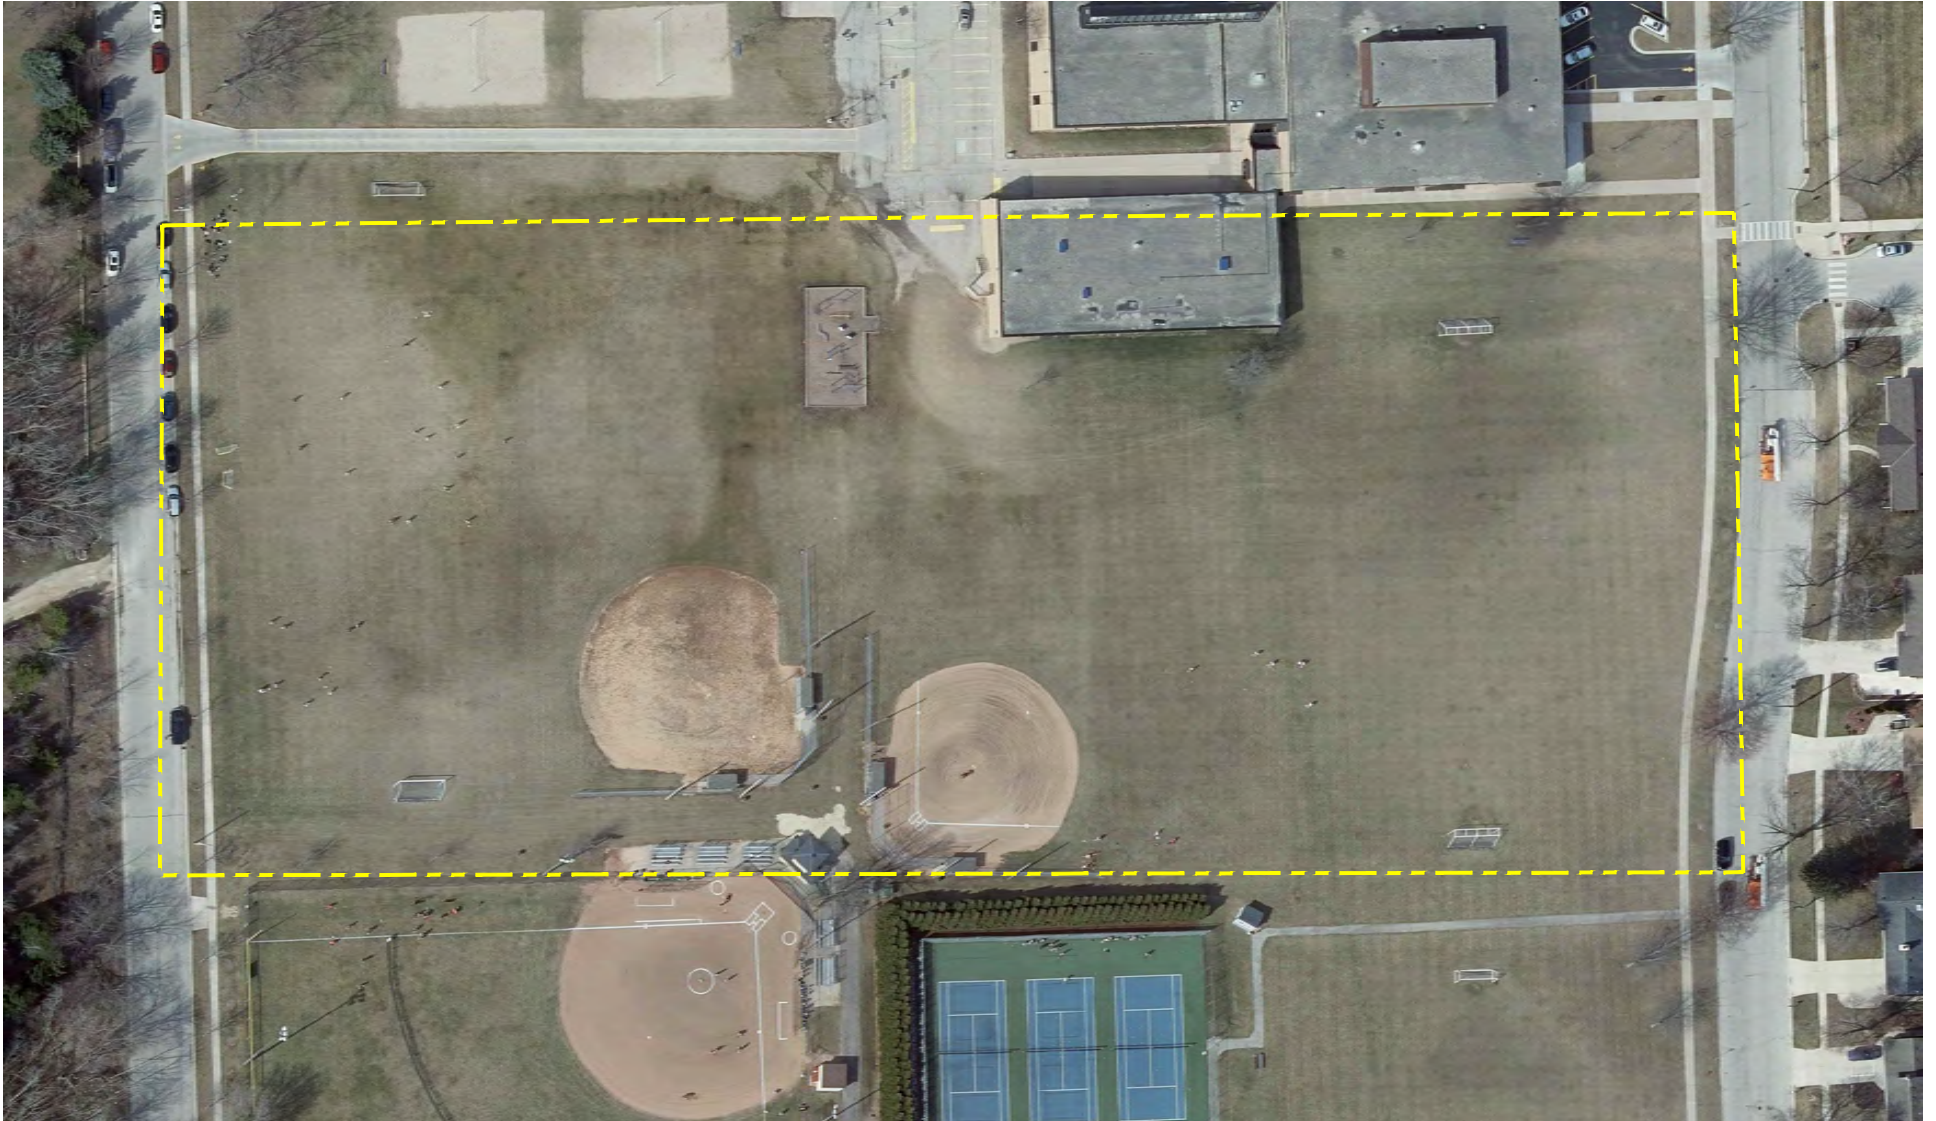
TJ MIDDLE SCHOOL SOFTBALL FIELDS
PORT WASHINGTON, WISCONSIN

Safety or ADA Issues	YES	
Rating Average	1.89

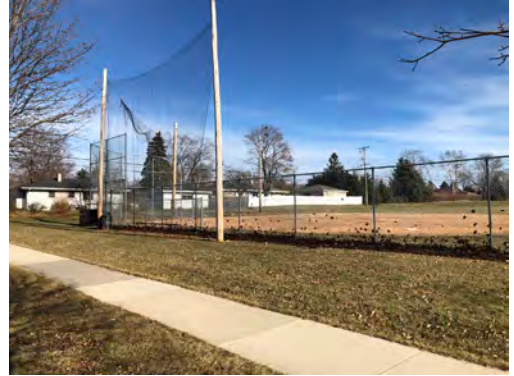
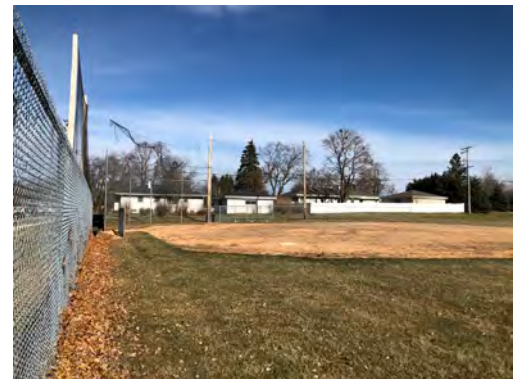
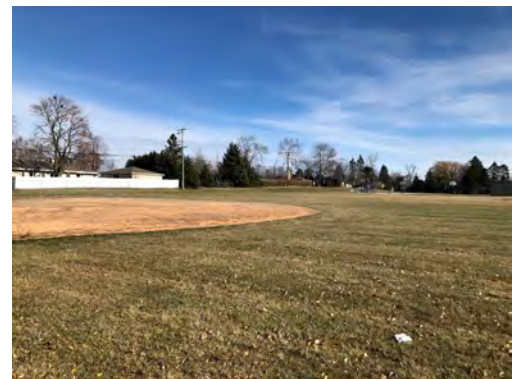
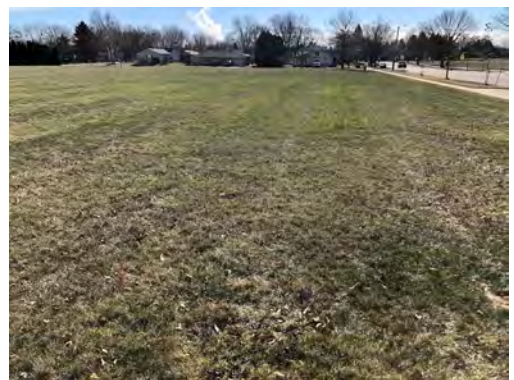
Name:	Lincoln Softball & Practice Soccer
Field Type:	Softball, Practice Soccer
Address:	1325 N Theis Lane Port Washington
Amenities	<ul style="list-style-type: none">▪ Benches▪ Backstop▪ Scoreboard

FIELD NAME: Lincoln Softball and Practice Soccer		
LOCATION: Lincoln Elementary School		
Specific Area	Rating	Comments
Size (Flexibility)	4	
Drainage	4	
Irrigation	N/A	
Backstop/Dugouts/Bleachers	2	
Infield Condition	2	
Outfield Condition	3	No defined outfield, shared with practice soccer
Lighting	N/A	
Restroom Facilities	1	
Concession	N/A	
Parking	3	
Fencing	2

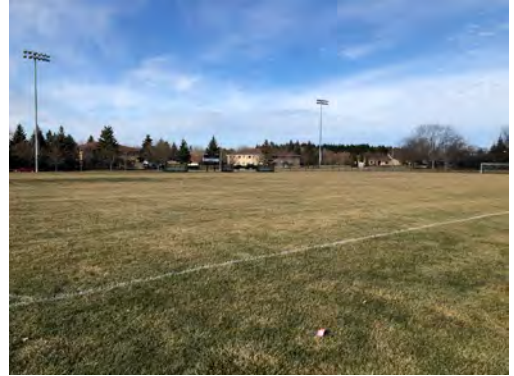
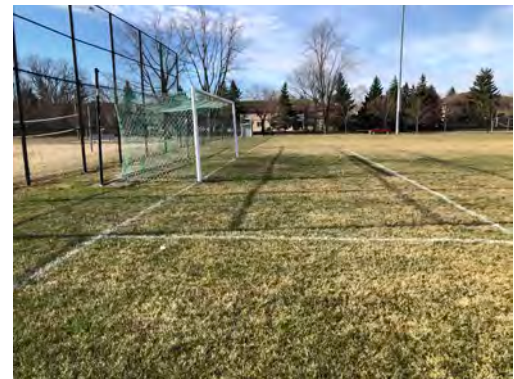
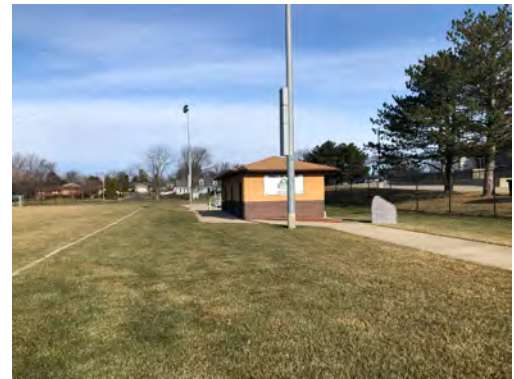
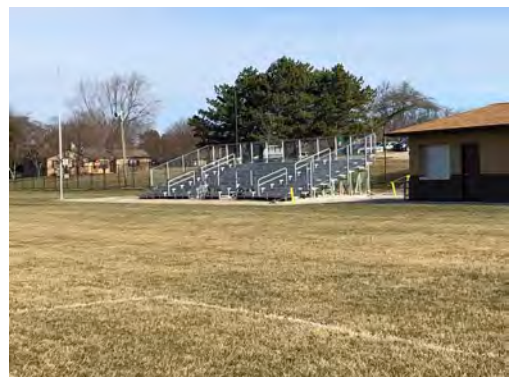
Name:	Varsity Soccer
Field Type:	Soccer
Address:	1403 N Holden Street Port Washington (At Thomas Jefferson Middle School)
Amenities	<ul style="list-style-type: none">▪ Bleachers▪ Benches▪ Backstop▪ Concessions▪ Grass Fields▪ Restroom▪ Scoreboard▪ Soccer Goals▪ Team Boxes▪ Officials Table▪ Lighting

FIELD NAME: Varsity Soccer Field		FIELD SIZE: 225' x 360'
LOCATION: Thomas Jefferson Middle School		
Specific Area	Rating	Comments
Size (Flexibility)	5	Team boxes, officials table, scoreboard for competition events
Drainage	3.5	Field is cross-drained east to west, ultimately should be crowned
Irrigation	4	
Goal Condition	5	
Overall Field Condition	4.5	
Bleachers/Benches	4	
Lighting	5	
Restroom Facilities	5	
Concession	5	
Parking	5	
Fencing	4

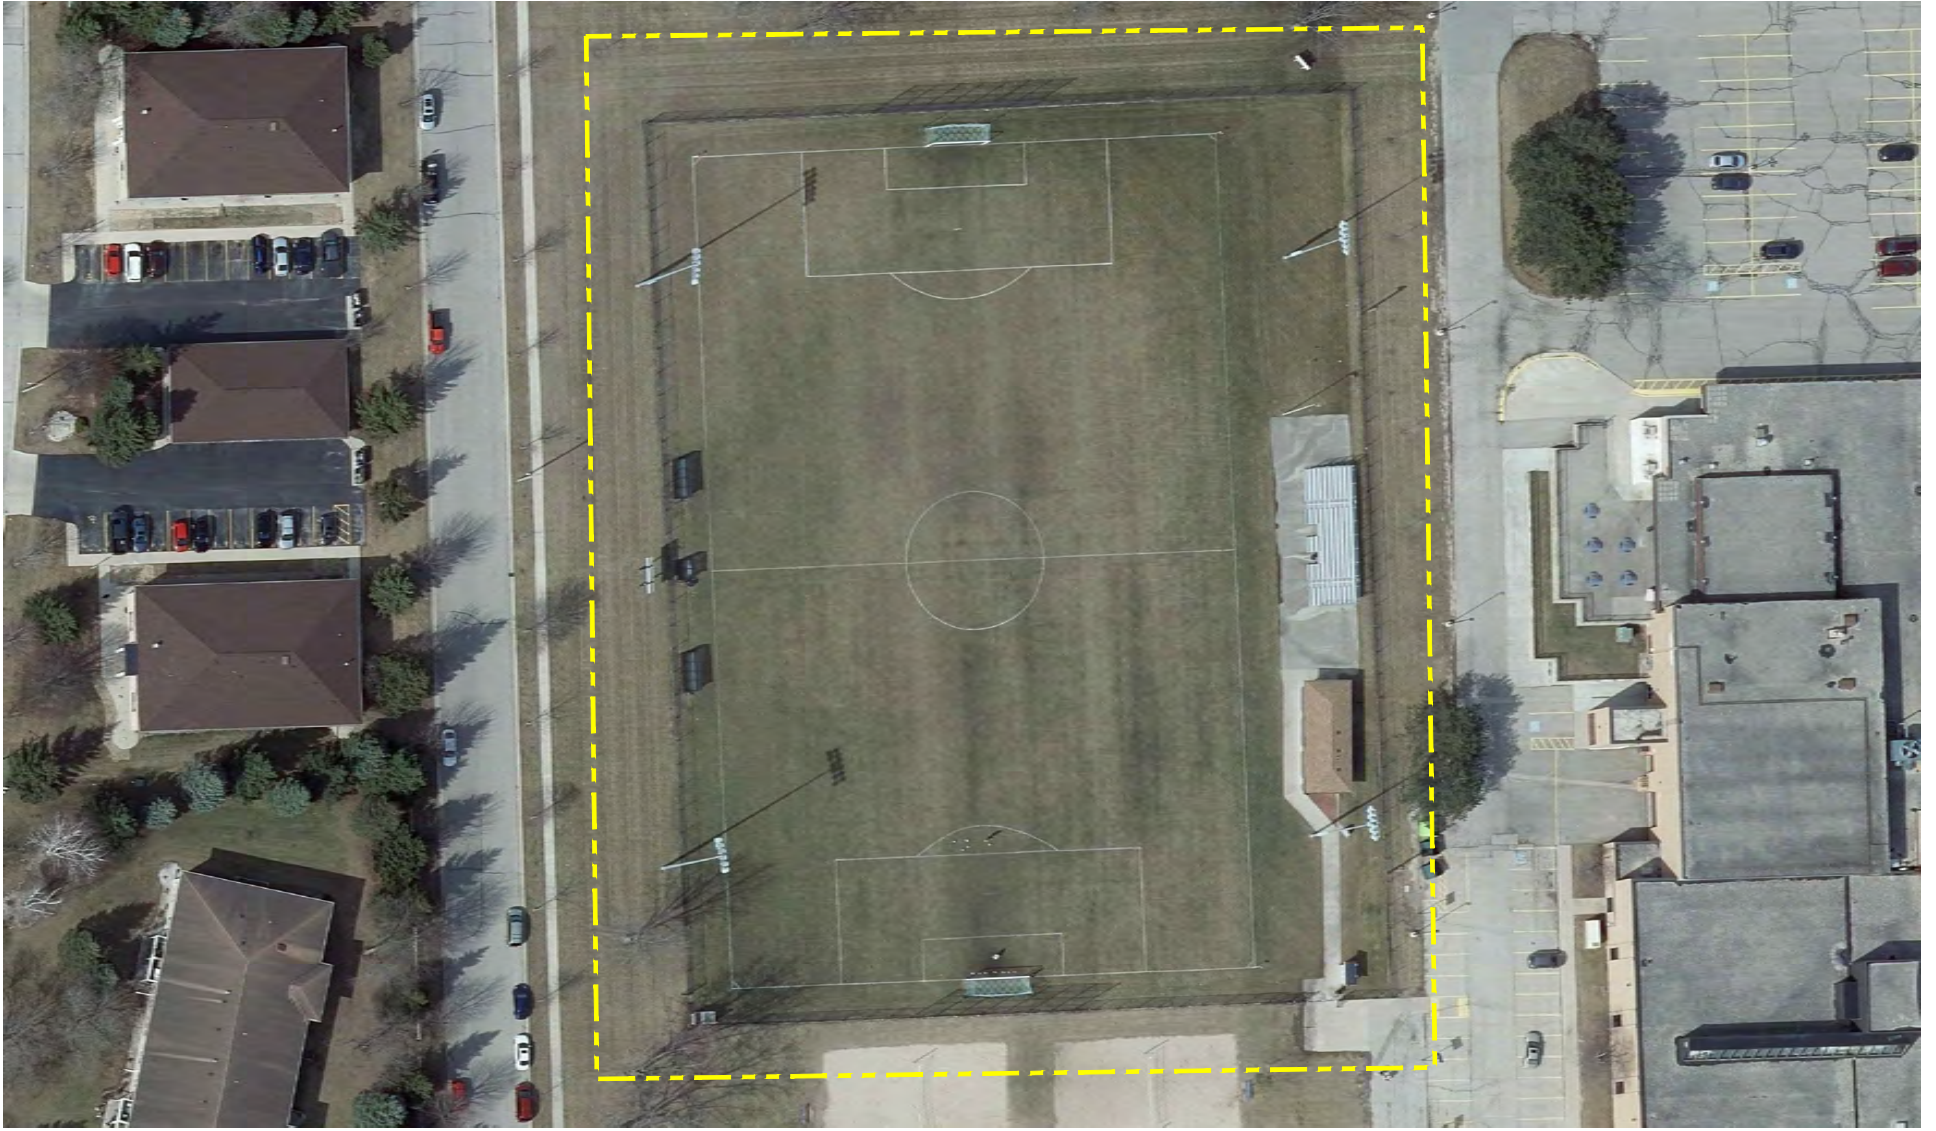
TJ MIDDLE SCHOOL SOCCER (VARSITY)
PORT WASHINGTON, WISCONSIN

Trees, playground equipment, and drainage structure in the field of play make this location a challenge for competition above youth and recreation activities.

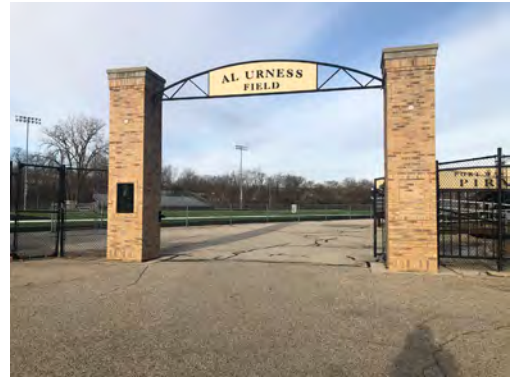
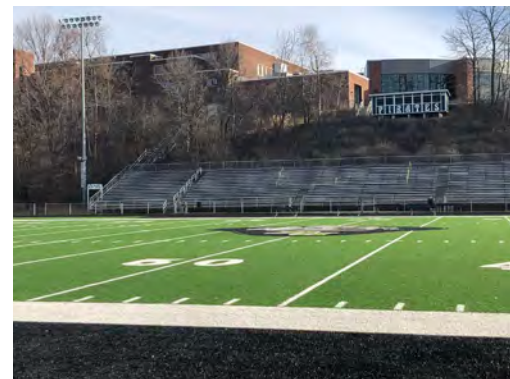
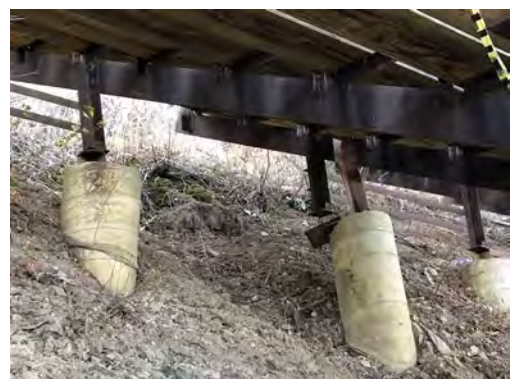
FIELD NAME: Al Urness Field		FIELD SIZE: Full Size Football
LOCATION: High School (Lower Campus)		
Specific Area	Rating	Comments
Size (Flexibility)	3.5	Football only
Drainage	5	
Irrigation	N/A	
Goal Condition	4	
Overall Field Condition	3.5	Grading inconsistency on playing surface in north end zone
Bleachers/Benches	1	Discontinue use of bleachers until replaced
Lighting	3	
Restroom Facilities	3	
Concession	3	
Parking	3	
Fencing	2

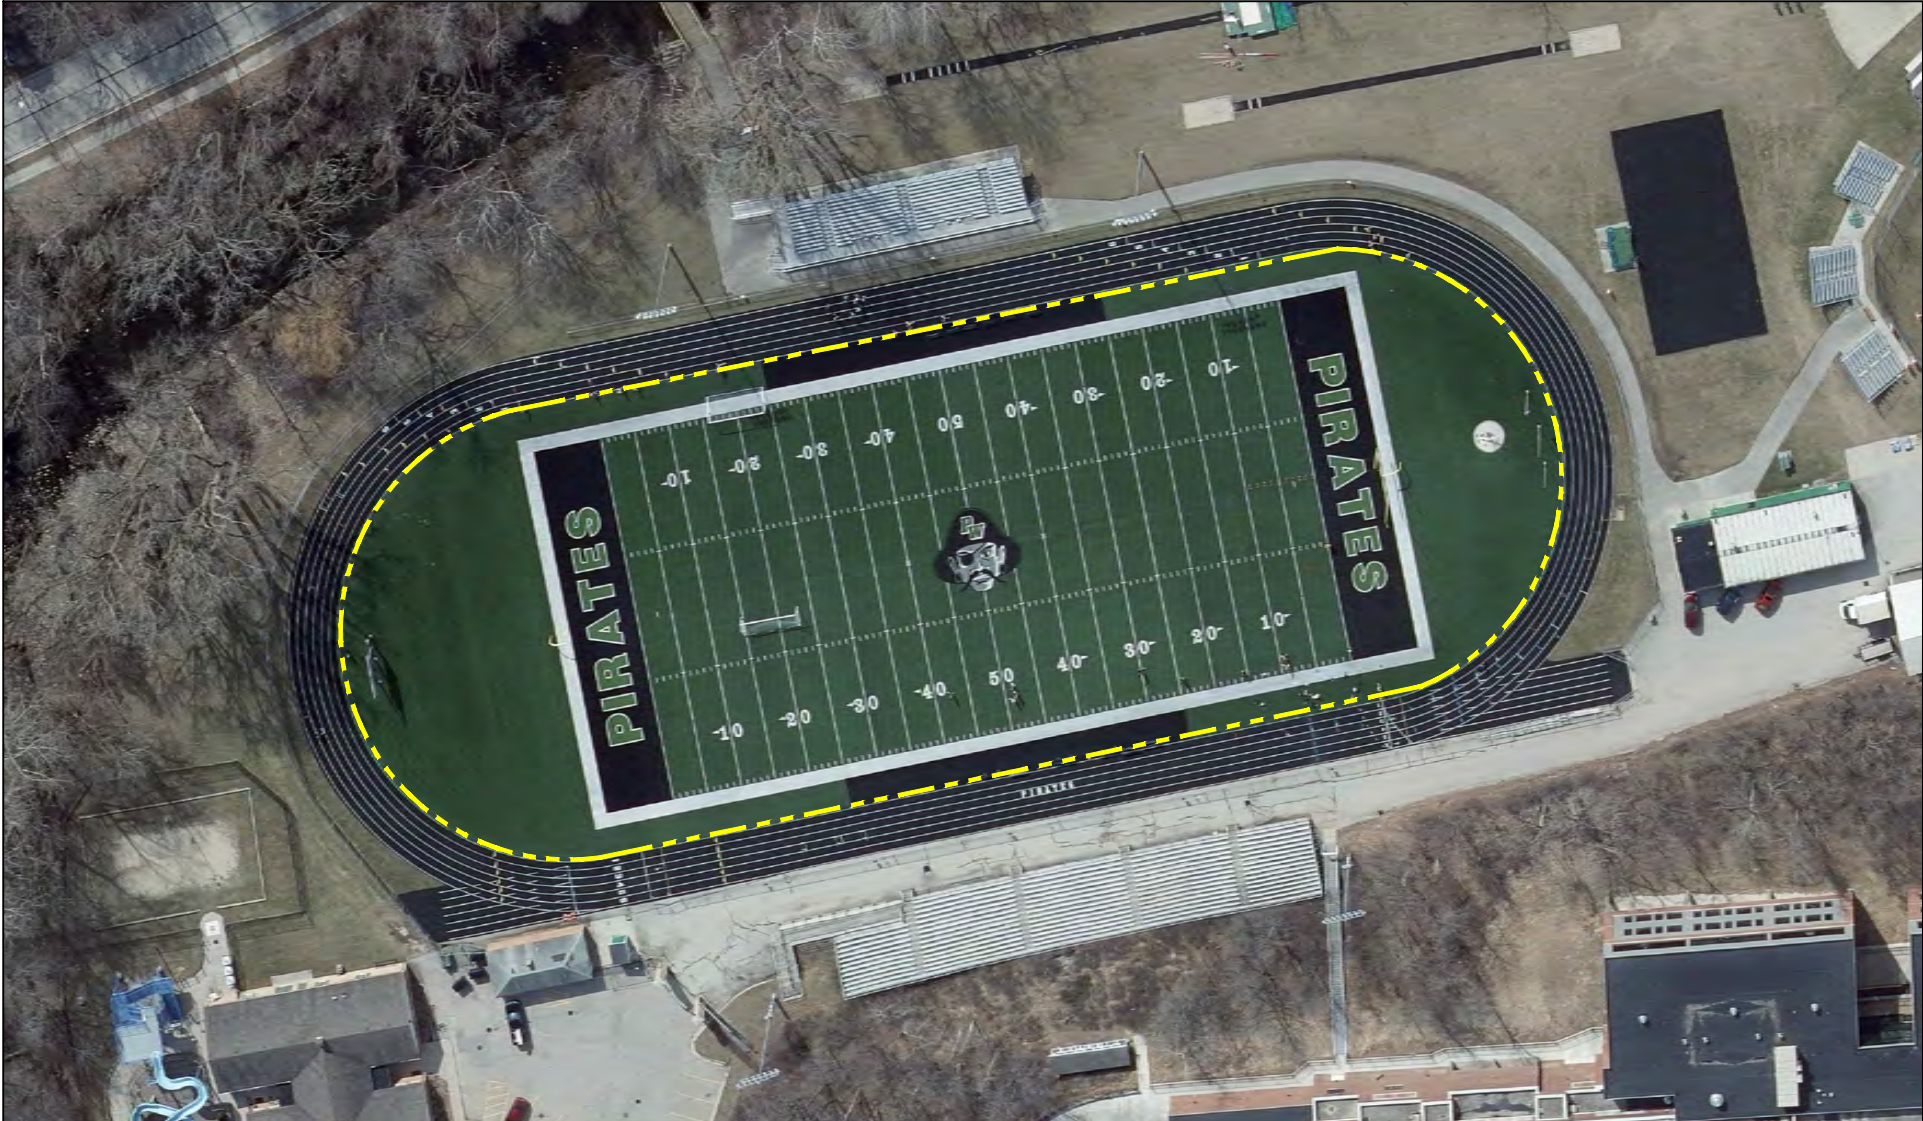
Field is limited to football use only. Very limited for added activities. Excellent competition venue with extensive improvements.

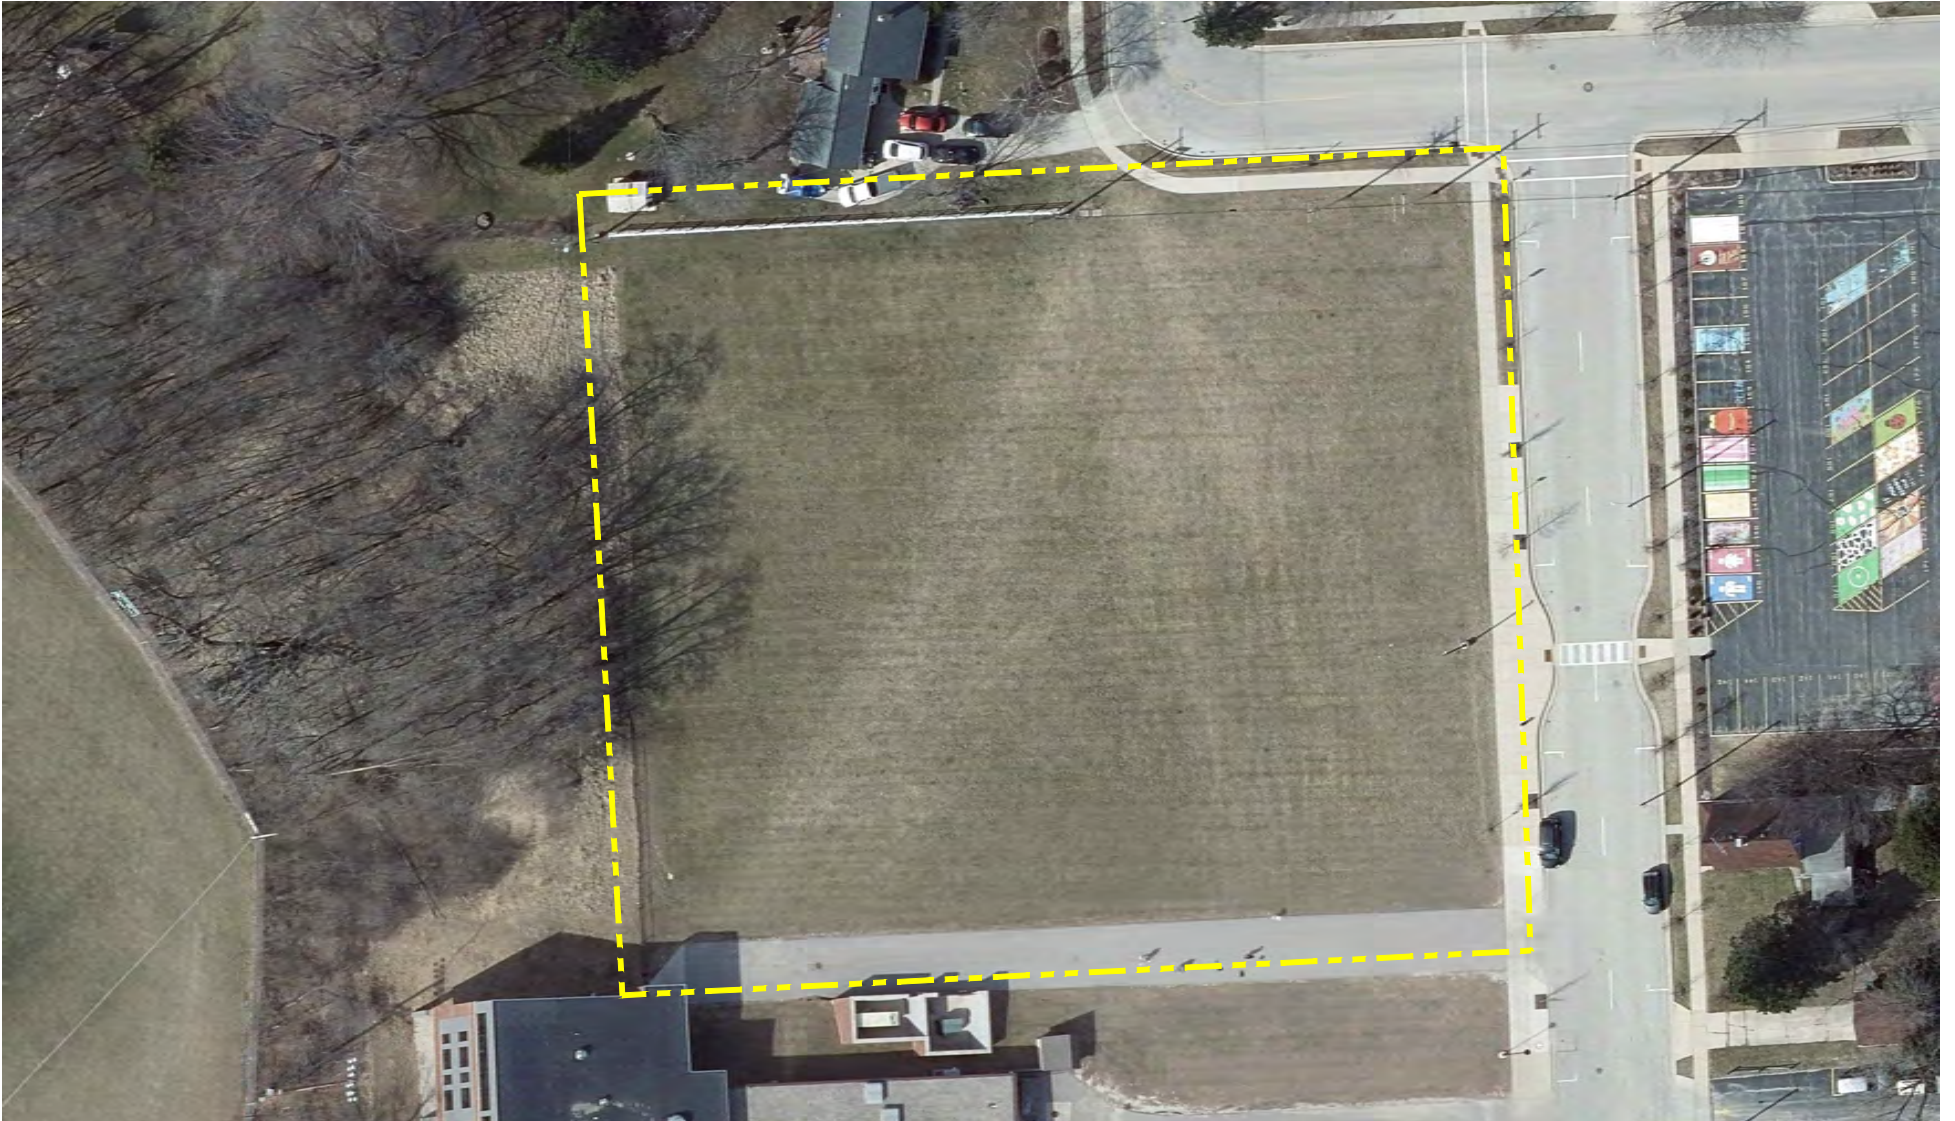
HIGH SCHOOL PRACTICE FIELD PORT WASHINGTON, WISCONSIN

FIELD NAME: HS Practice Field		FIELD SIZE: 250' x 265'
LOCATION: High School (Upper Campus, North Side)		
Specific Area	Rating	Comments
Size (Flexibility)	3	
Drainage	2	
Irrigation	N/A	
Goal Condition	N/A	
Overall Field Condition	2	
Bleachers/Benches	N/A	
Lighting	N/A	
Restroom Facilities	1	
Concession	1	
Parking	4	
Fencing	N/A

Safety or ADA Issues	YES	
Rating Average	2.17

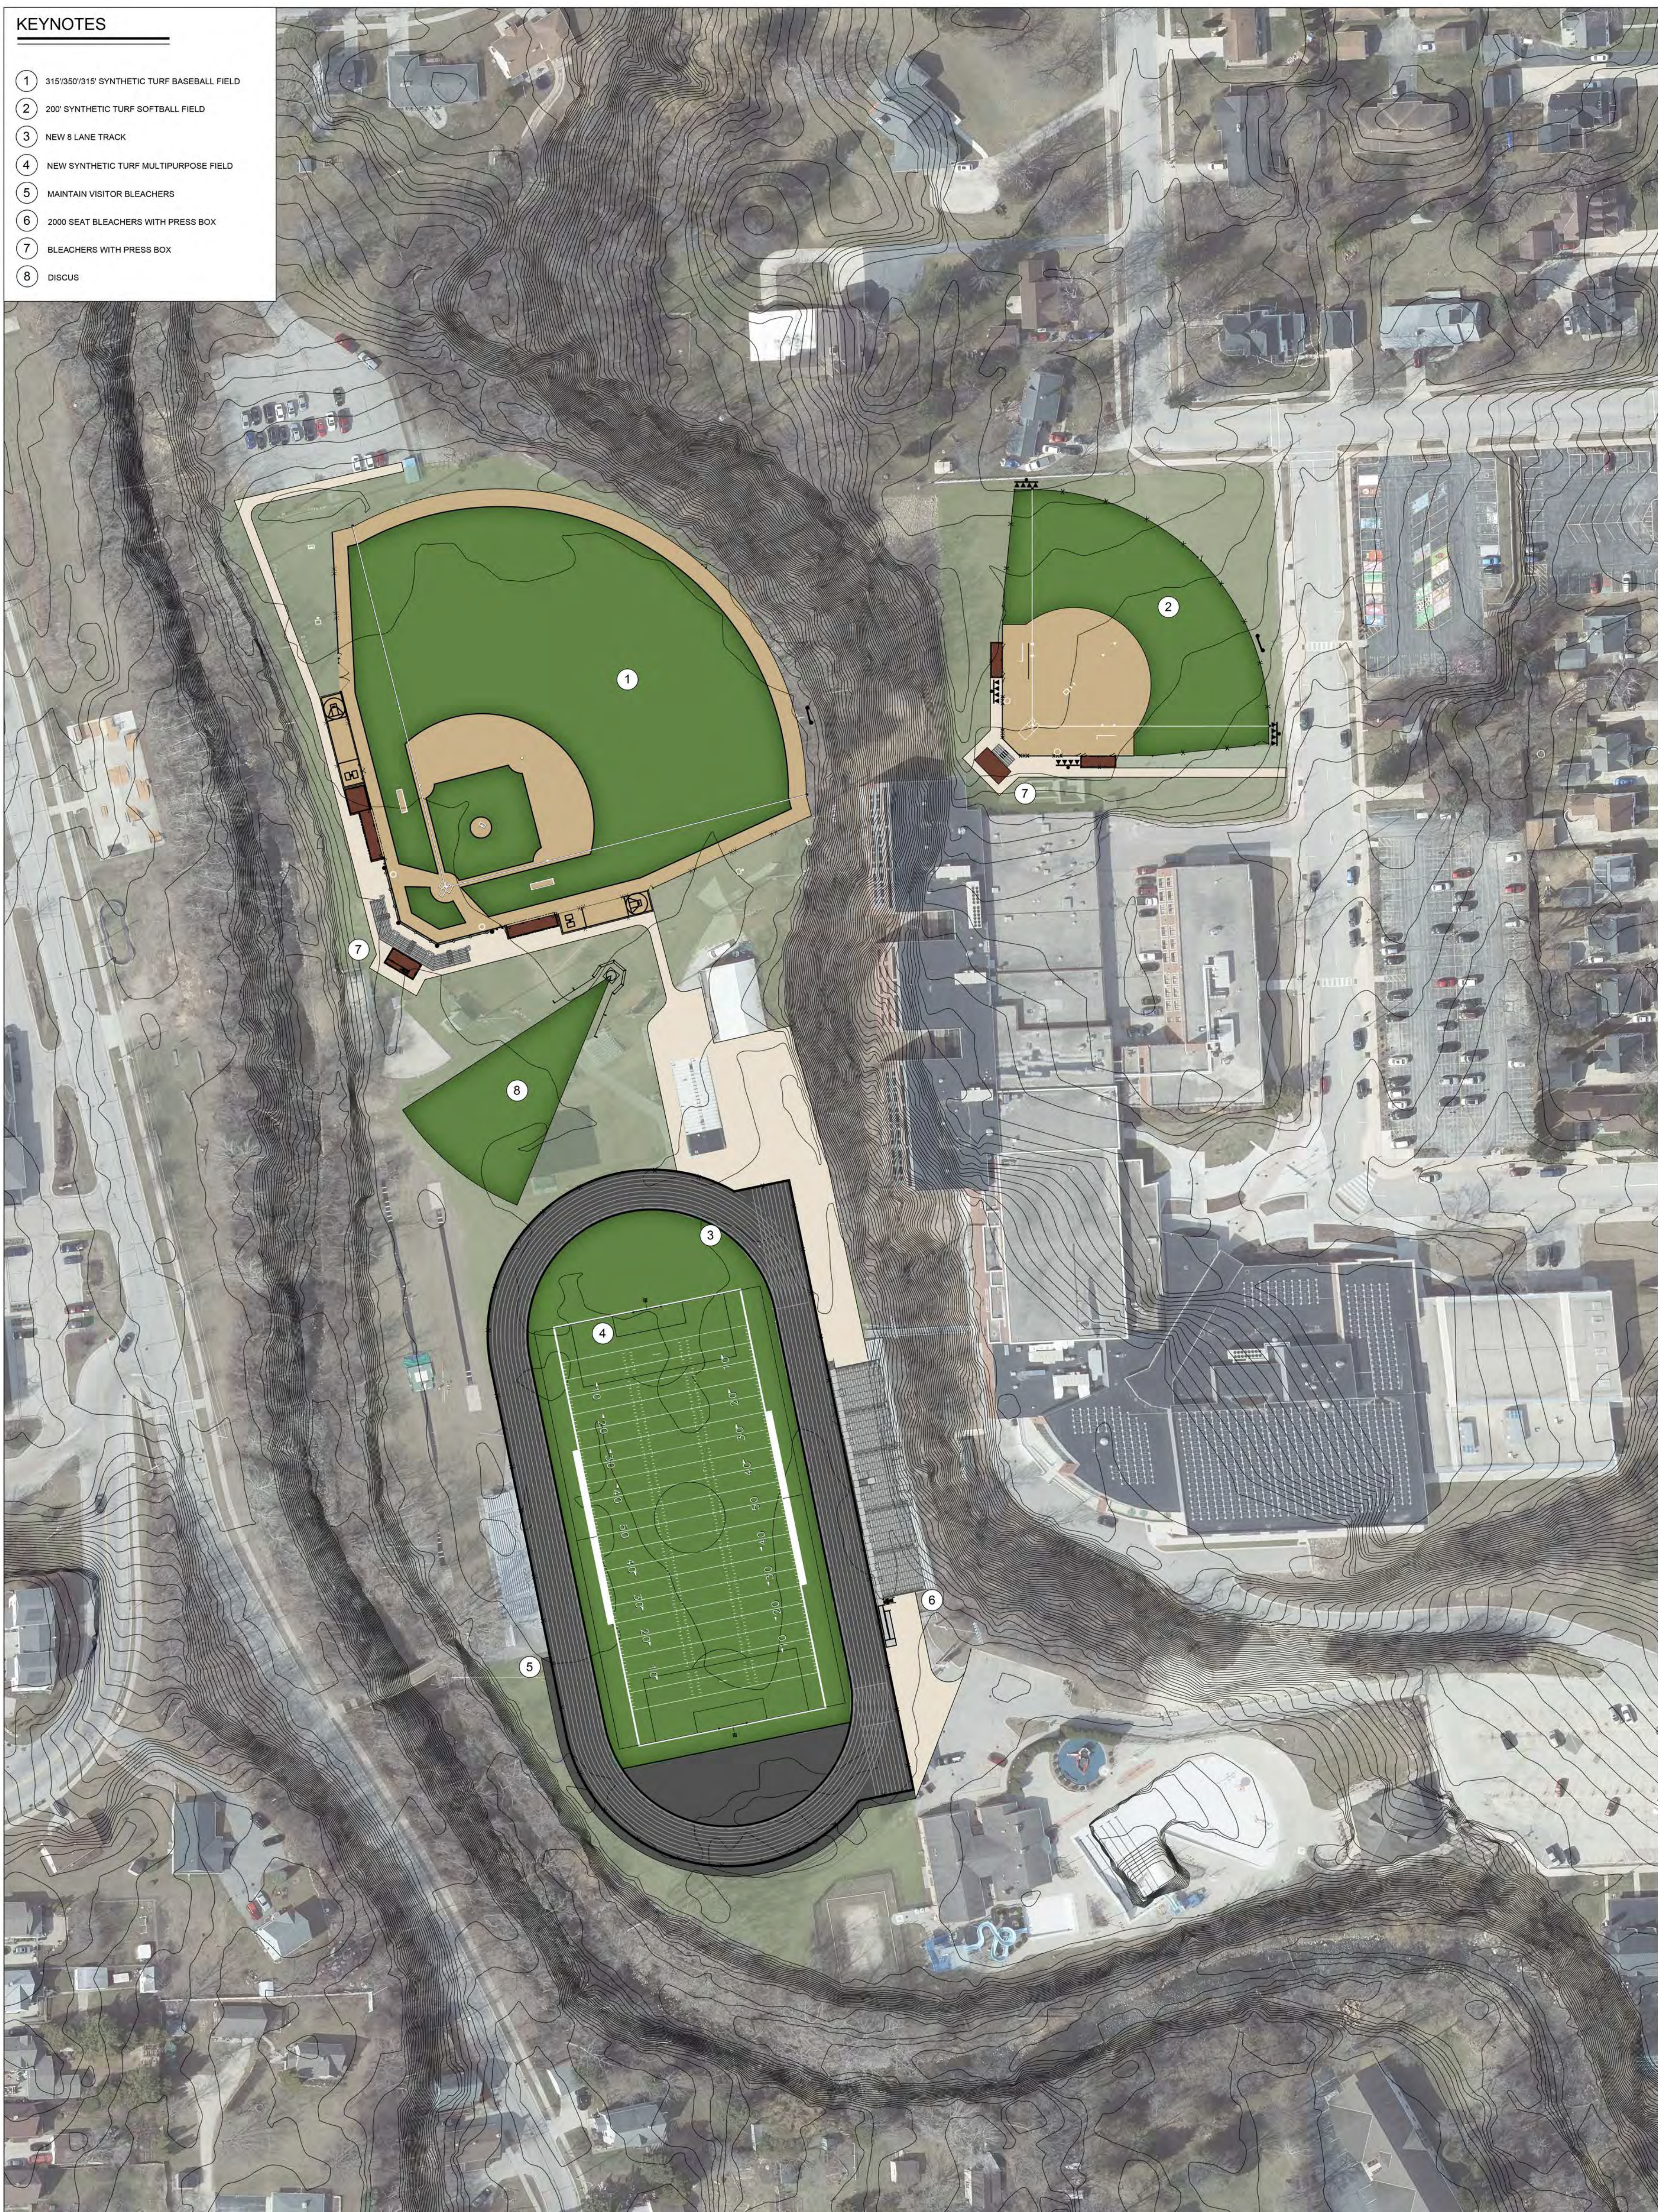
PORT WASHINGTON
SITE RECOMMENDATIONS ■ CONCEPT 1
427 W JACKSON ST, PORT WASHINGTON, WI 53074

- ① 315/350/315' SYNTHETIC TURF BASEBALL FIELD
- ② 200' SYNTHETIC TURF SOFTBALL FIELD
- ③ NEW 8 LANE TRACK
- ④ NEW SYNTHETIC TURF MULTIPURPOSE FIELD
- ⑤ MAINTAIN VISITOR BLEACHERS
- ⑥ 2000 SEAT BLEACHERS WITH PRESS BOX
- ⑦ BLEACHERS WITH PRESS BOX
- ⑧ DISCUS

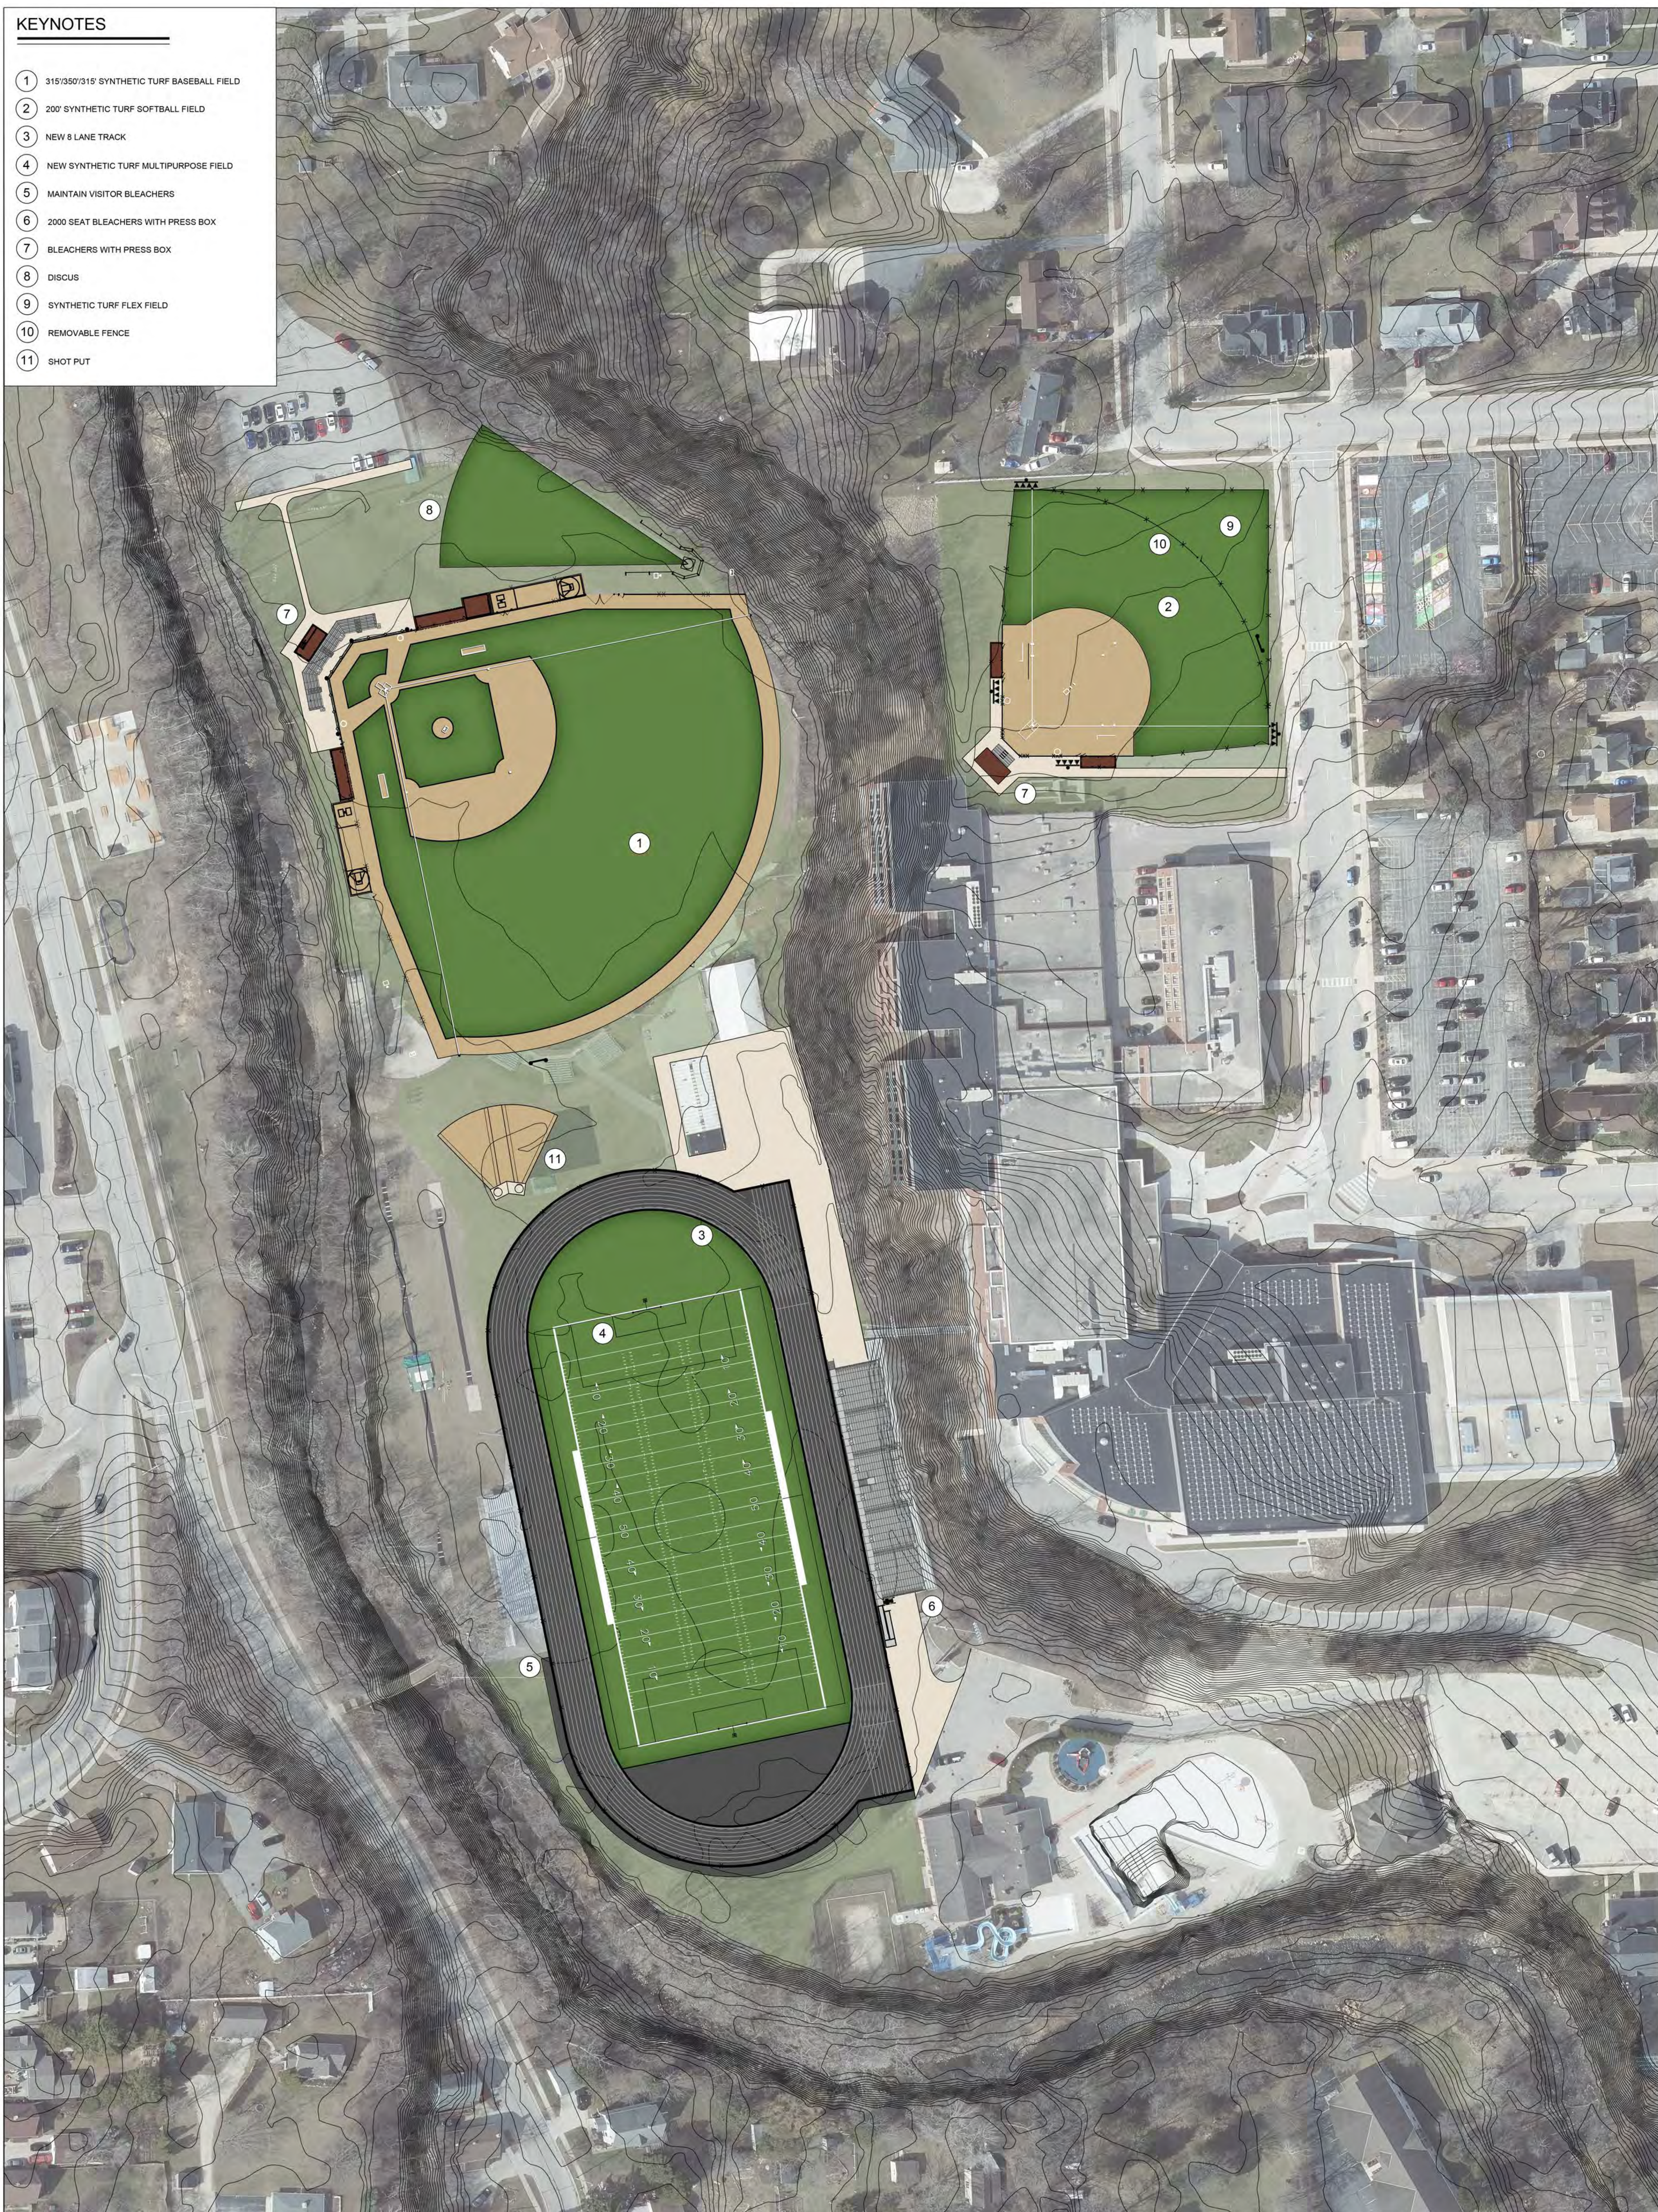
PORT WASHINGTON
 SITE RECOMMENDATIONS ■ CONCEPT 2
 427 W JACKSON ST, PORT WASHINGTON, WI 53074

- ① 315/350/315' SYNTHETIC TURF BASEBALL FIELD
- ② 200' SYNTHETIC TURF SOFTBALL FIELD
- ③ NEW 8 LANE TRACK
- ④ NEW SYNTHETIC TURF MULTIPURPOSE FIELD
- ⑤ MAINTAIN VISITOR BLEACHERS
- ⑥ 2000 SEAT BLEACHERS WITH PRESS BOX
- ⑦ BLEACHERS WITH PRESS BOX
- ⑧ DISCUS
- ⑨ SYNTHETIC TURF FLEX FIELD
- ⑩ REMOVABLE FENCE
- ⑪ SHOT PUT

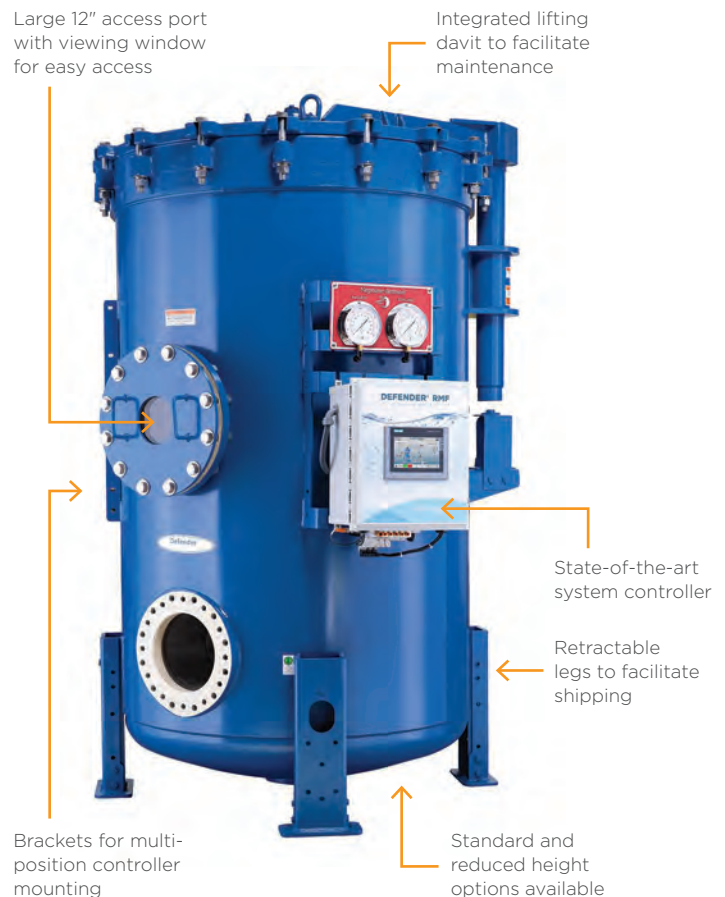
REGENERATIVE MEDIA FILTERS

Simply put regenerative media filters are nothing like traditional sand filters. Neptune Benson pioneered development of RMF technology to provide aquatics venues with the clearest, cleanest and safest water possible!

- 3.1** Replace existing high rate sand filtration with Re-Generative media filtration (See Appendix A). Regenerative Media (RM) filters push water through a collection of flexible tubes covered with a polyester woven fabric. The tubes and fabric are coated with filter media (Diatomaceous earth or Perlite) which collects particulates. Cleaning an RM filter involves draining the filter, refilling, and draining again. This process may be required every month to 6 weeks, depending on use. New media is applied when the tank is refilled via a vacuum. The bump cycle is automated, but manually activated by pushing a button. The draining of the filter and refilling the media is a manual process assisted by the filter components. RM filtration reduces water consumption drastically by only requiring cleaning every four to six weeks. This in turn reduces the chemical usage and heating demands since such a small amount of water is leaving the system. RM filters are capable of filtration in the 1 to 5-micron range, filter rates are 1.0 to 2.0 gpm/sf of filter area. Two RM filters would be required due to space access limitations. Manufacturers of Regenerative media filters include [Evoqua](#) and [Paddock](#).

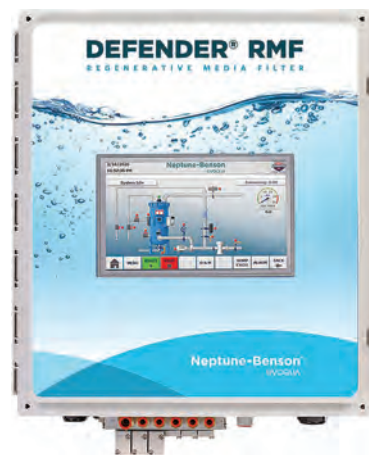
SYSTEM CONTROLLER

RMF operations are controlled through a fully redesigned high resolution LCD control panel. Crisp real-time graphics depicting system status, user-friendly on-screen menus and touch-screen navigation make operation simple and intuitive. Remote monitoring capabilities allow you to access system data from outside of the mechanical room.

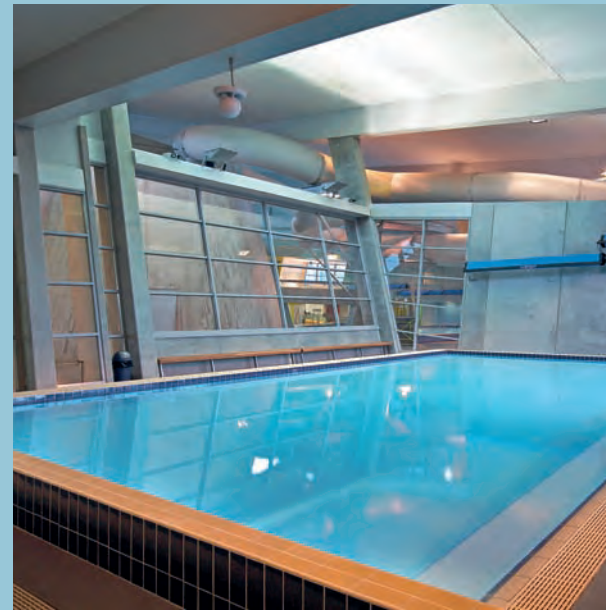
Minimum Interventions, Zero Demolitions

RenovAction does not require destructive demolition of the existing structure, thereby resulting in considerable savings with regard to both the installation time and overall costs. The internal surface of the original pool remains unchanged and only the accessories on the walls or floor will need to be replaced.
