Port Washington-Saukville School District

Athletic & Outdoor Facilities Master Plan Study

Draft: August 2023

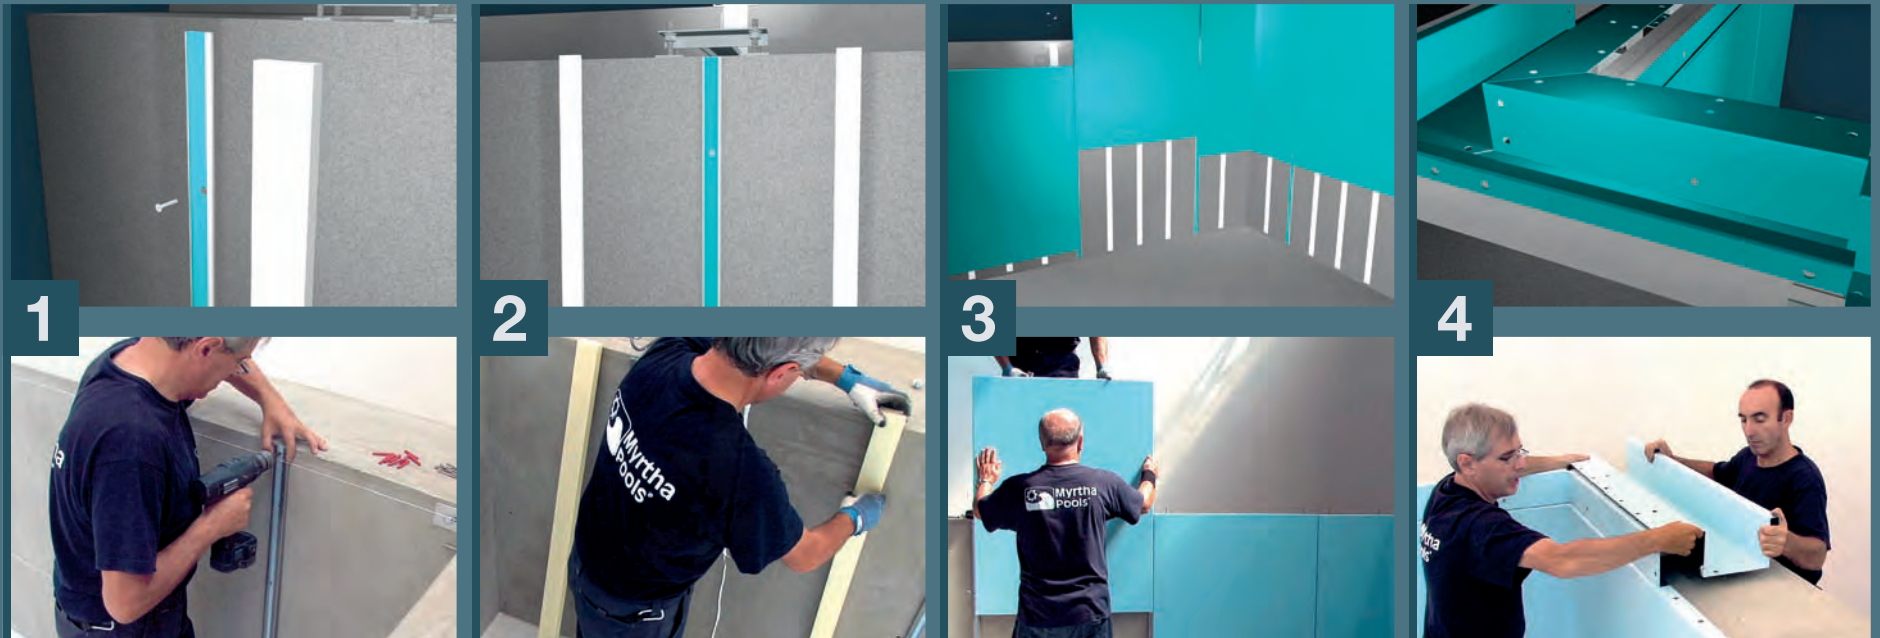
The Installation Process

The RenovAction installation process is both simple and fast, without the possibility of mistakes or delays in the renovation work.

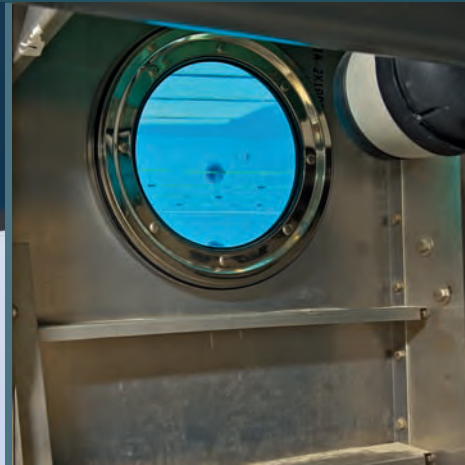
Portholes and Windowed Walls

For competition pools originally equipped with portholes or windowed walls, RenovAction technology offers the possibility to maintain the same accessories in the renovated project. RenovAction panels are positioned in the original openings in the walls. Portholes or windows for the underwater photography or video are installed in the panels with a special flange system.

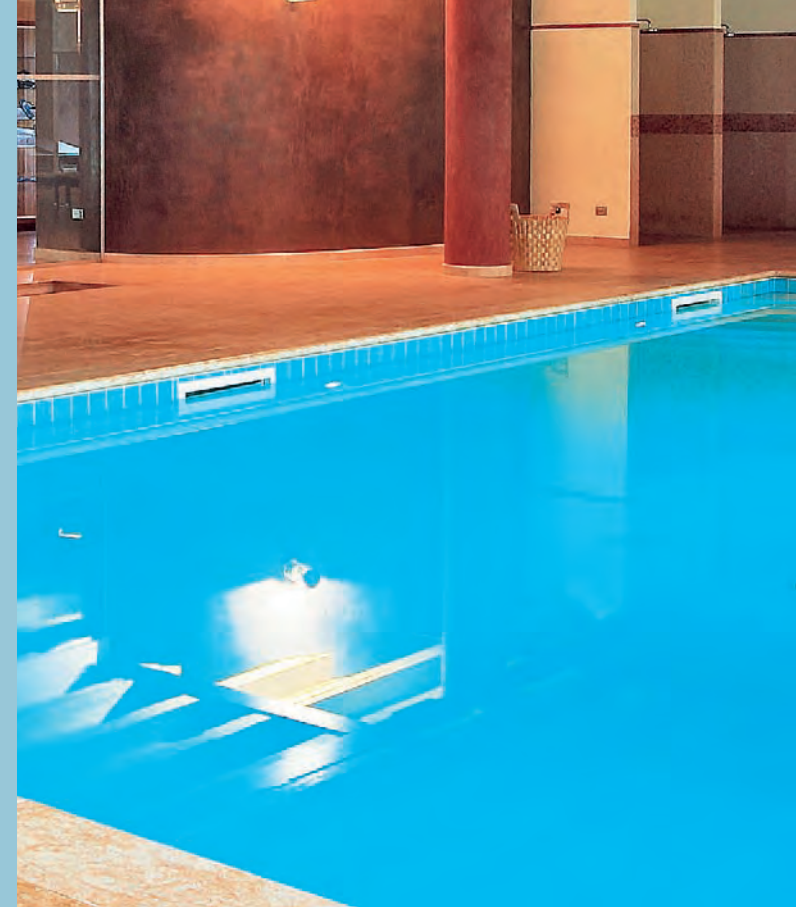
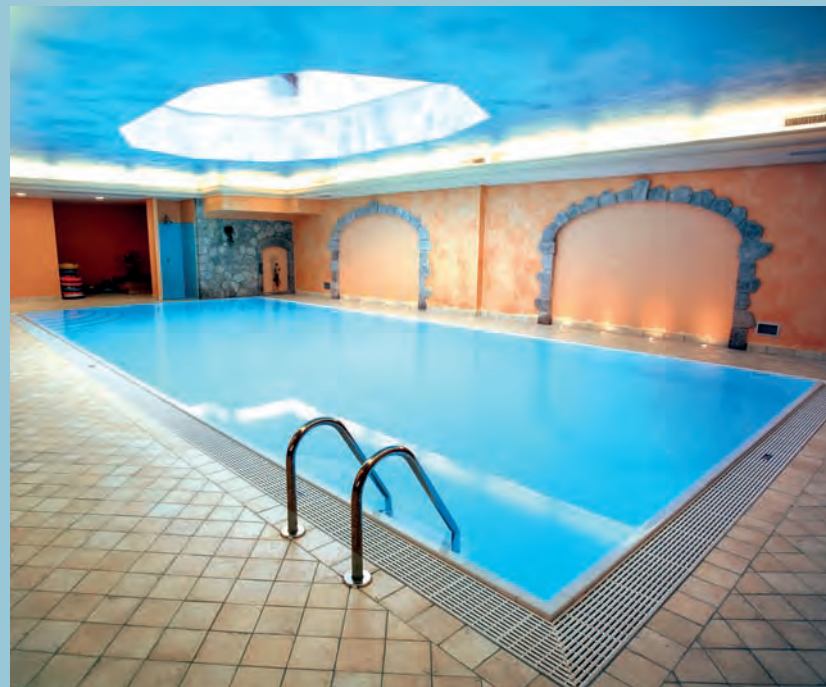
Overflow Gutter Classic

The Myrtha Classic Overflow gutter is ideal for all pools and guarantees an excellent water flow. It has reduced dimensions while still maintaining an aesthetically uniform mirroring surface. It is completed with a simple but smart PVC finish on the upper part of the panel.

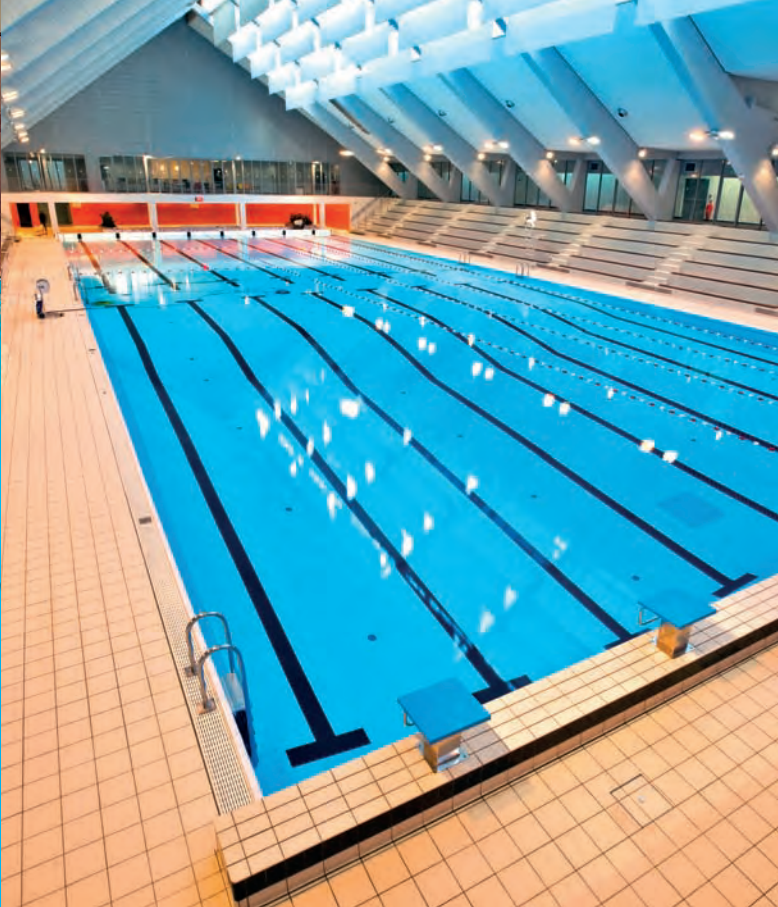
Overflow Gutter Classic Competition

This structure is ideal for large competition pools, as the PVC coping is flush with the wall panels, either on entire perimeter of the pool or on the two short sides only. This technology is also the most suitable for the renovation of pools that need to meet international regulations. Both the Classic and the Classic Competition gutter styles are available with a wide variety of finishes.

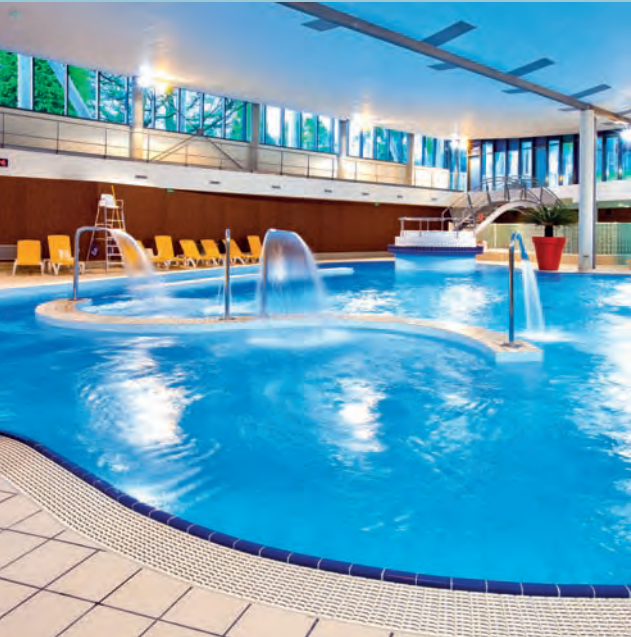
Overflow Gutter Structural

The Myrtha Structural Overflow technology is distinguished by a ceramic tile that functions as a structural component of the wall panels. This structure guarantees a perfect overflow level while maintaining an attractive finish and can be considered the ideal technology for public leisure pools with any design.

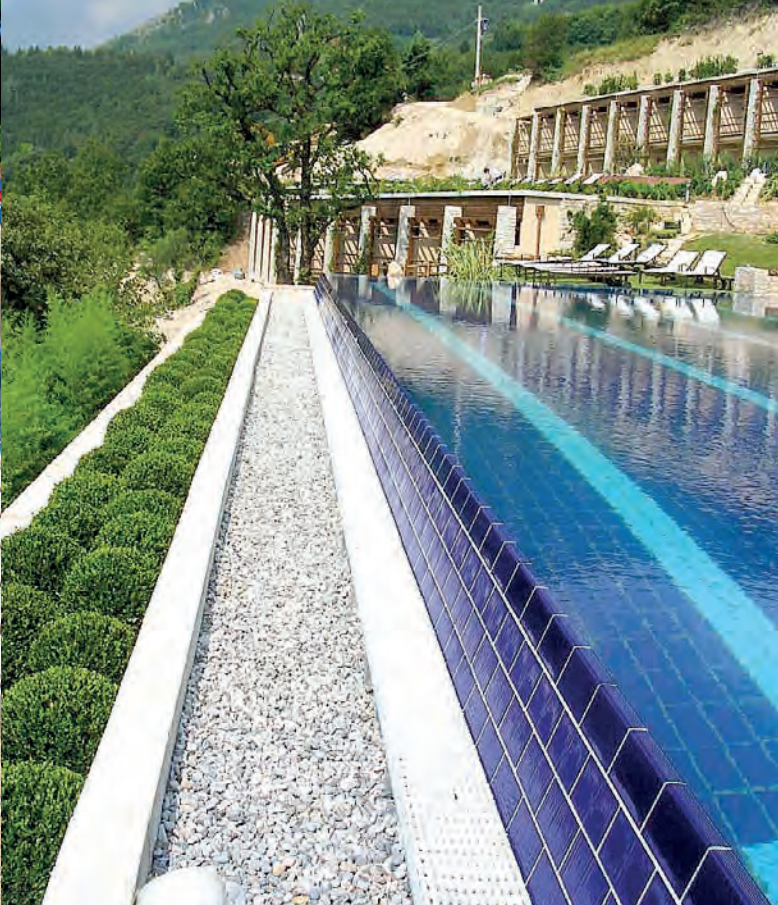
Vanishing Edge Structural

The Vanishing Edge Structural technology is an evolution of the Vanishing Edge Ceramic 1 profile. Structural ceramic tiles overlay the Myrtha wall panels in a gentle slope, creating a cascade effect into the gutter.

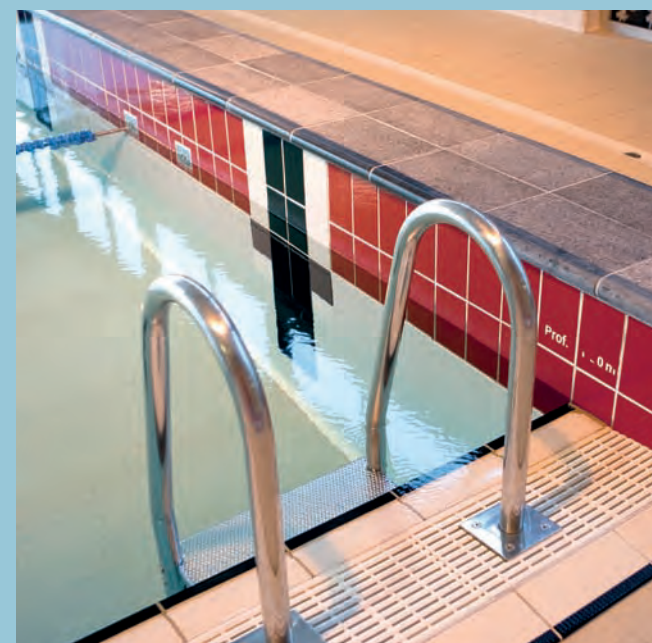
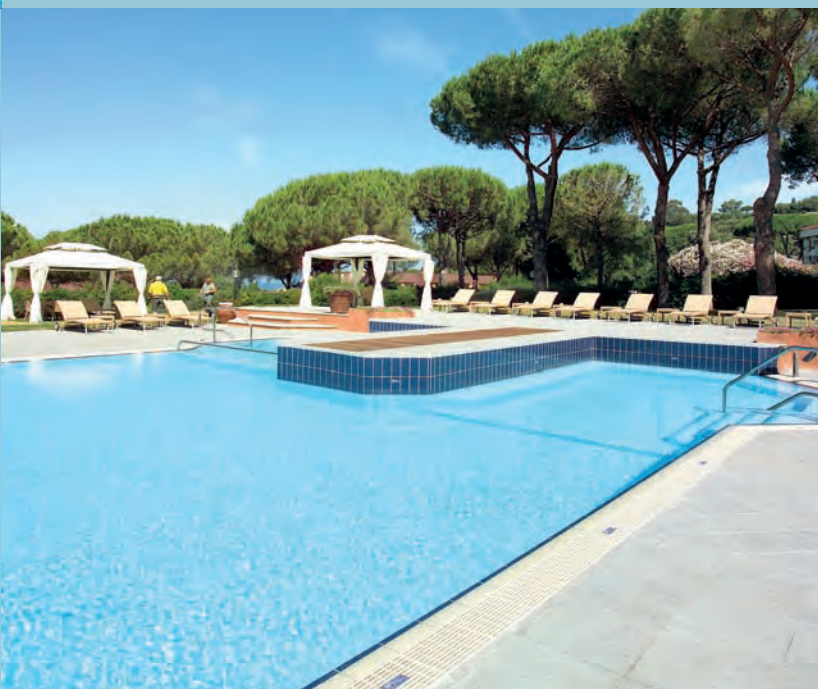
Combined Technologies

All of the technologies described above can be combined to meet specific design requirements. For example, competition pools can combine overflow technologies with headwalls; public and leisure pools combine skimmer systems with one or more vanishing edges or headwall systems. Myrtha Pools offers the work of a specialized technical staff who continuously search for the best solutions for the client according to their needs and surroundings.

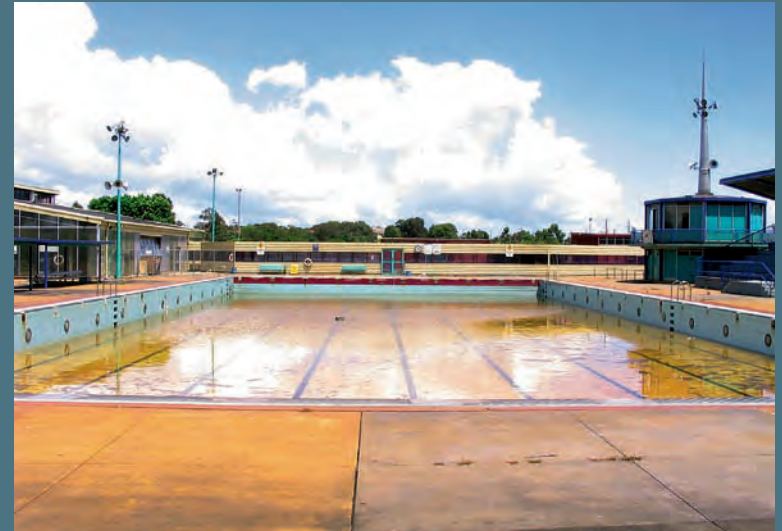
Phase

Installation of Myrtha components started from the side with the ramp. This side was completely built with Myrtha Technology and adjusted according to the width of the ramp. Once the base frame was installed, the new RenovAction panels were affixed to the existing wall. Upon completion of the panels installation, the overflow channel is positioned and secured in place. The RenovAction panels were installed directly onto the walls of the other three sides of the pool.

Vertical spacers were installed between the RenovAction panels and the concrete pool walls to compensate for any imperfections in the existing structure. Finally, the floor membrane and mosaic lane markings were applied.

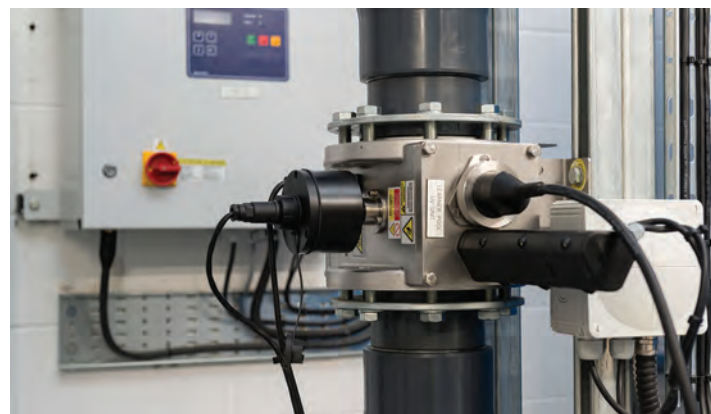
- Smaller installation footprint
- Horizontal or vertical installation
- More efficient and enhanced power control
- Higher performance
- Simpler and faster to maintain
- Increased safety
- Modbus®
